HORTON LAKE DAM

NDI No. PA 00070
PennDER No. 58-124
Dam Owner: Harry Horton

PHASE I INSPECTION REPORT
NATIONAL DAM INSPECTION PROGRAM

Horton Lake Dam, Susquehanna County, Pennsylvania
NDI No. PA 00070, PennDER No. 58-124
Sterling Brook
Inspected 30 October 1980

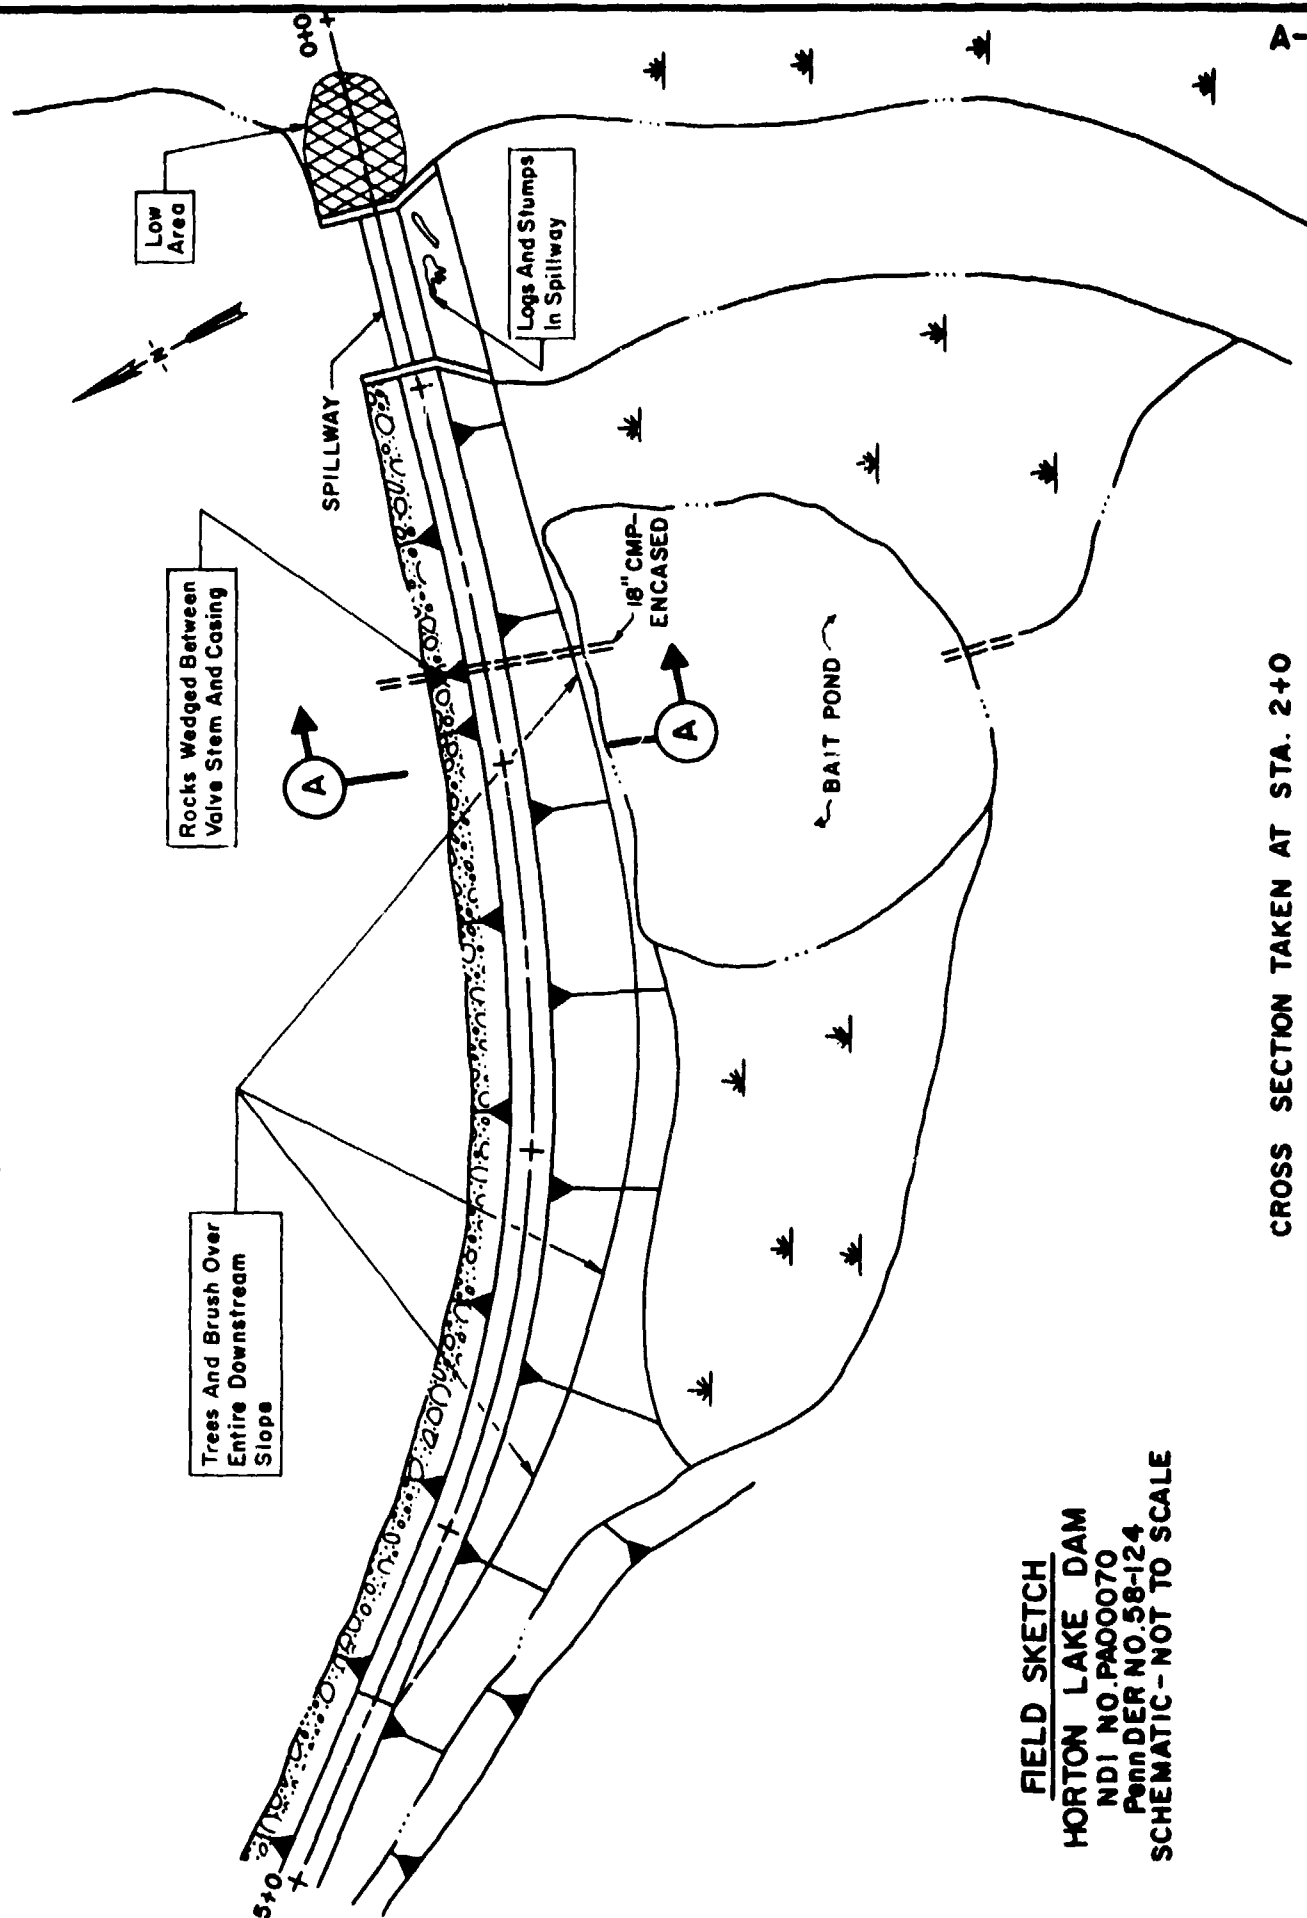
FIELD SKETCH
HORTON LAKE DAM
 NDI NO. PA00070
 Penn DER NO 58-124
 SCHEMATIC - NOT TO SCALE

a. General - The dam was found to be in good overall condition at the time of inspection on 30 October 1930. No unusual weather conditions were experienced during the inspection. Noteworthy deficiencies observed during the visual inspection are described briefly in the following paragraphs. The complete visual inspection check list, field sketch, top of dam profile, and typical cross-section are presented in Appendix A.
